**DEPARTMENT OF TRANSPORTATION****DIVISION OF ENGINEERING SERVICES**

Contract #: 04-0120F4Cty: SF/ALA Rte: 80 PM: 13.2/13.9File #: 13.28**WELDING INSPECTION REPORT****Resident Engineer:** Pursell, Gary**Address:** 333 Burma Road**City:** Oakland, CA 94607**Report No:** WIR-011275**Date Inspected:** 06-Jan-2010**Project Name:** SAS Superstructure**OSM Arrival Time:** 1000**Prime Contractor:** American Bridge/Fluor Enterprises, a JV**OSM Departure Time:** 1830**Contractor:** Oregon Iron Works Clackamas, Or.**Location:** Clackamas, OR**CWI Name:** M. Gregson, J. Salazar**CWI Present:** Yes No**Inspected CWI report:** Yes No N/A**Rod Oven in Use:** Yes No N/A**Electrode to specification:** Yes No N/A**Weld Procedures Followed:** Yes No N/A**Qualified Welders:** Yes No N/A**Verified Joint Fit-up:** Yes No N/A**Approved Drawings:** Yes No N/A**Approved WPS:** Yes No N/A**Delayed / Cancelled:** Yes No N/A**Bridge No:** 34-0006**Component:** Hinge K Pipe Beams**Summary of Items Observed:**

**Hinge-K Pipe Beam Assembly 102A-3****a111-3 Forging to a110-3 Base Plate**

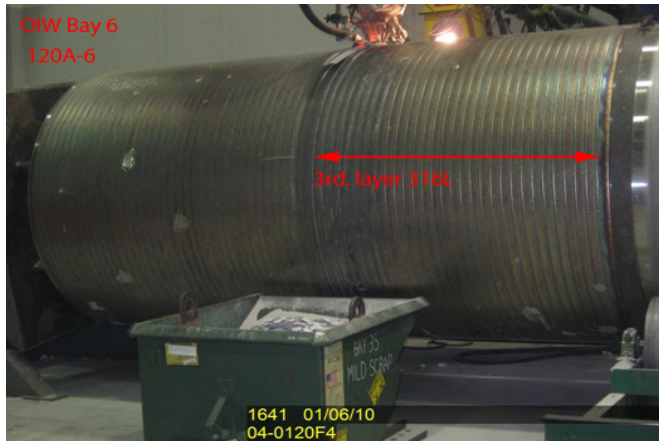
The QA Inspector noticed that the third and final ESW stainless steel overlay passes were in-process, on this fuse assembly 120A-6. QA Inspector witnessed welder #J6, Mr. Craig Jacobson performing electro slag welding (ESW) on the third layer welding passes, in the flat position. The QA Inspector noted that the third layer pass was now approximately 30% complete and Soudokay brand Soudotape 316L stainless steel consumable strip, was

being utilized. The QA Inspector randomly noticed QC Inspector Jose Salazar was present, to verify in-process welding parameters (amps/volts) and monitor in-process continuous pre-heat temperatures. QC Inspector Salazar explained to the QA Inspector that welding amperage was previously recorded at 1200 amps/24.5 volts, travel speed at 229mm/min. and a pre-heat temperature recorded at 70 degrees Fahrenheit (21 C). The QA Inspector verified the welding parameters and the minimum pre-heat temperatures were in compliance with the applicable WPS 7003. The QA Inspector verified Mr. Craig Jacobson was currently qualified for this welding process and position. The QA Inspector noted that the ESW being performed appeared to be in compliance with WPS 7003. See attached picture below.

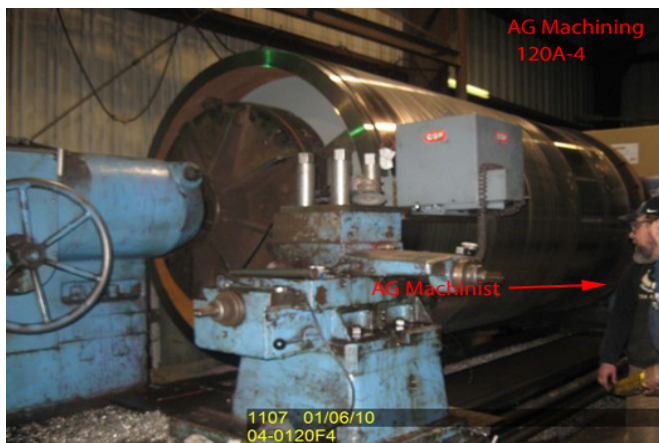
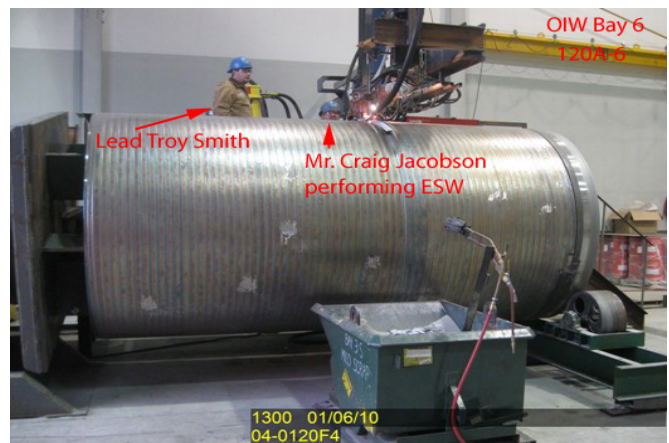
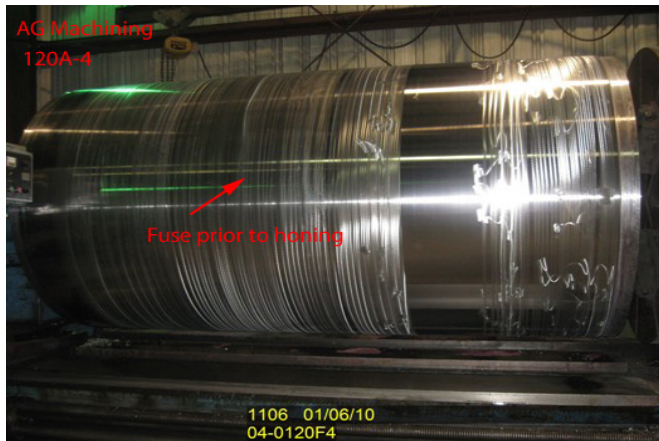
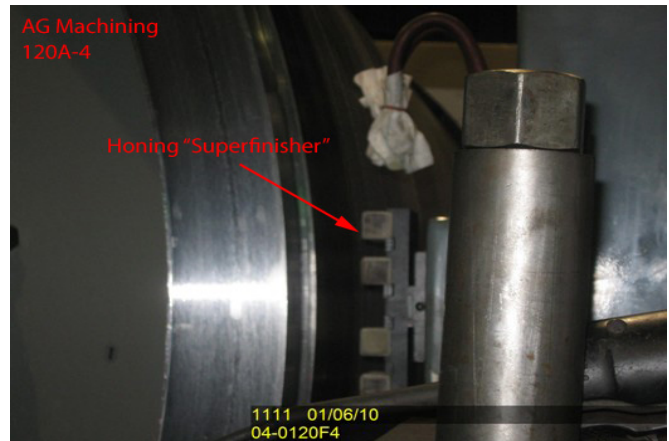
On this date, the QA Inspector arrived at AG Machining to witness the final machining on Fuse 120A-4. The QA Inspector met with the AG machinist and AG explained that the third and final cut pass had been previously completed. AG explained that after the third and final cut pass was completed, that approximately 10 surface inclusions were still present in the overlay, that will require weld repairs. AG explained that they were currently in-process of setting up to hone the entire surface overlay, utilizing a superfinisher. AG explained that the honing will polish the surface overlay to the minimum contract requirements of .8um. AG explained that after the honing is complete, OIW will arrive to perform the excavations and weld repairs, on the overlay surface. See attached pictures below.
